**Compressive Residual Strength  
of Graphite/Epoxy Laminates After Impact**

**Submitted in Partial Fulfillment of the  
Requirements for the Degree of**

**MASTER OF SCIENCE**

**AERONAUTICS AND ASTRONAUTICS**

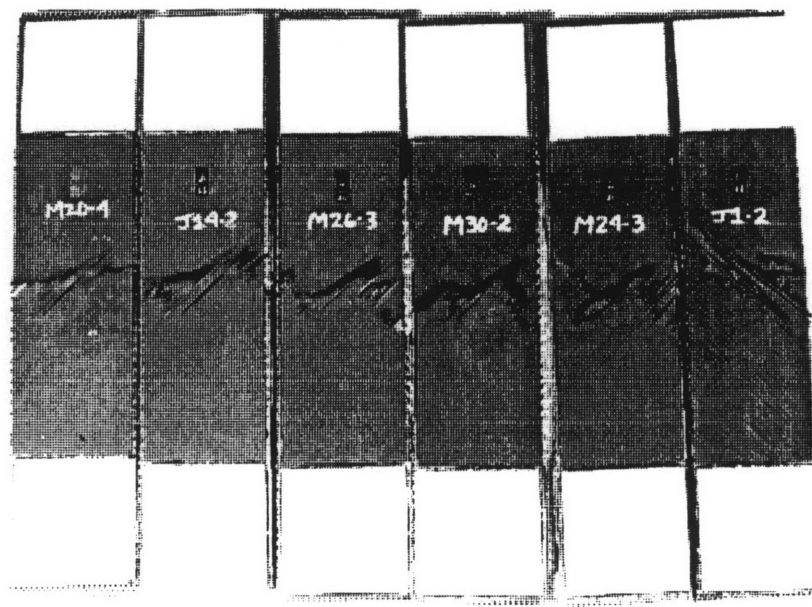
Figure 4.21 Photograph of Impact-Damaged Specimens After Fracture  
(Impacter Mass = 578 g, Velocity = 7.5 m/s).

Photographs of the fractured specimens impacted at the lowest velocity, MCRS-velocity, and highest velocity with the 578 g mass in this work are presented in Figures 4.21 through 4.23. The photographs of specimens impacted at 7.5 m/s, in Figure 4.21, and at 9.2 m/s, in Figure 4.22, show evidence of sublaminar buckling. Again, upon postmortem inspection, the sublaminar was consistently found to include only ply 1 (45°) and the remaining plies showed fiber failure across the width. The specimens that exhibit delamination appear to fail straight across the coupon width as evidenced by Specimens J1-3 in Figure 4.21, and Specimens M20-4, J14-2 in Figure 4.22. Specimen J1-3 in Figure 4.21, which exhibits delamination, resulted in the highest compressive residual strength of the two specimens (364 MPa). Specimen J15-3, with back surface spalling, fiber failure, and no evidence of delamination, resulted in the lowest compressive residual strength of the two specimens (257 MPa). These correlations are similar to those seen in Figure 4.12 for specimens
